LAXTON CONSERVATION AREA APPRAISAL

MARCH 2022

Title: Draft Laxton Conservation Area Appraisal; March 2022

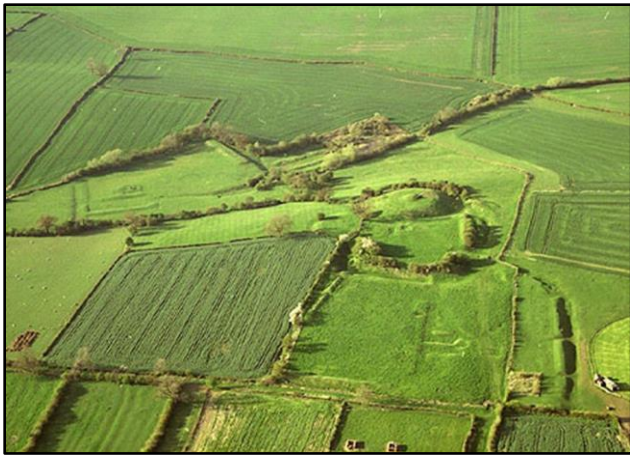
Fig.4 Aerial of Laxton's Motte and Bailey

The Rous family held Laxton during the 16th century. The family seem to have been peaceful and prosperous country squires and are likely to have built the manor house in front of the site of the old Norman castle, which at this point had fallen into decay⁶.

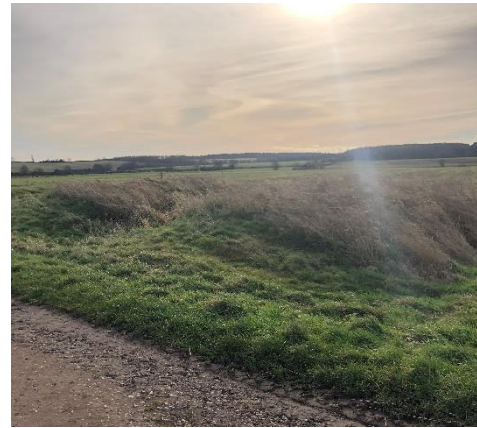
Fig.12 Possible ridge and furrow within the open-field

in landscaping features that have been formed from the past cultivation of the land. These elements have potential archaeological interest.

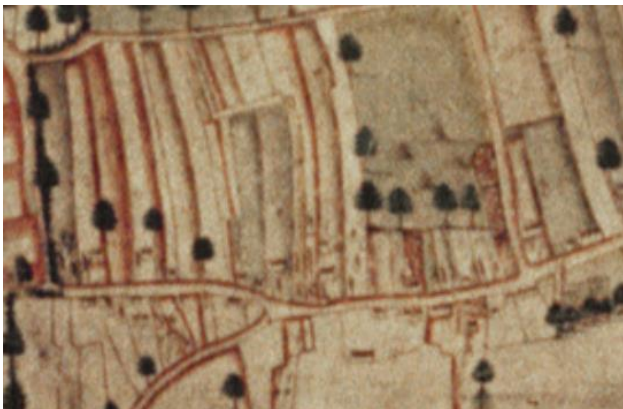
Behind the farmhouses and cottages are crofts, which are linear plots that run towards the back lanes. These crofts were used as orchards or areas to keep animals. Some of the remaining crofts can be identified on Mark Pierce's Map.

Fig.15 Crofts along town end and high street depicted on Mark peierce's 1635 map

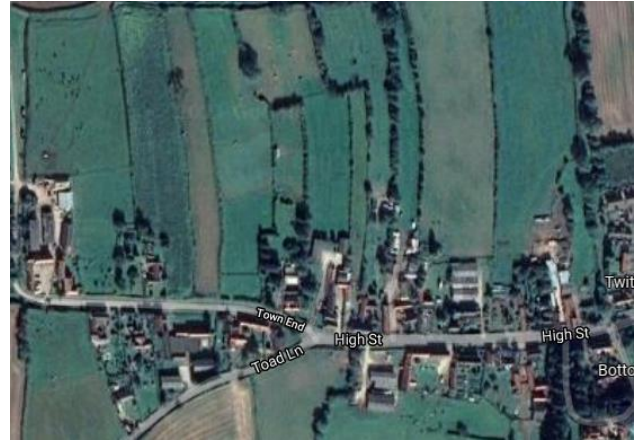
Fig.16 Historic croft pattern still remain along town end and high street

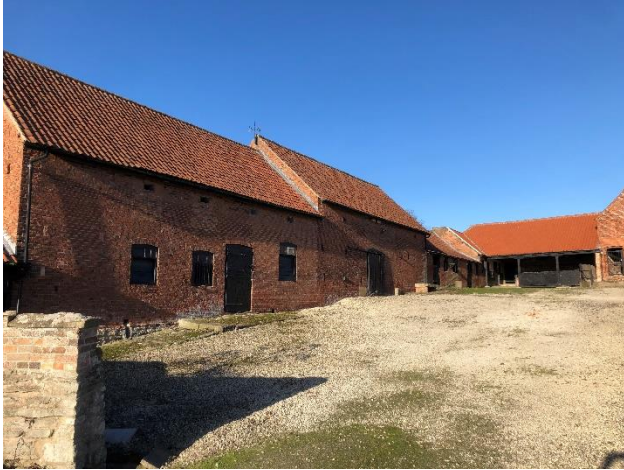
Fig.17 Traditional agricultural buildings can be found throughout the village including threshing barns, stables and pigsty

Unlike many rural villages, there are many farmhouses and farm buildings located within the village centre; this is a consequence of the open-field system. The farmyards are a prominent feature within the village and creates a different character compared to other rural villages in the district. The layout of the farmhouses, cottages and farmyards are varied throughout the village. The farmsteads typically have a mixture of traditional farm buildings including threshing barn and stable.

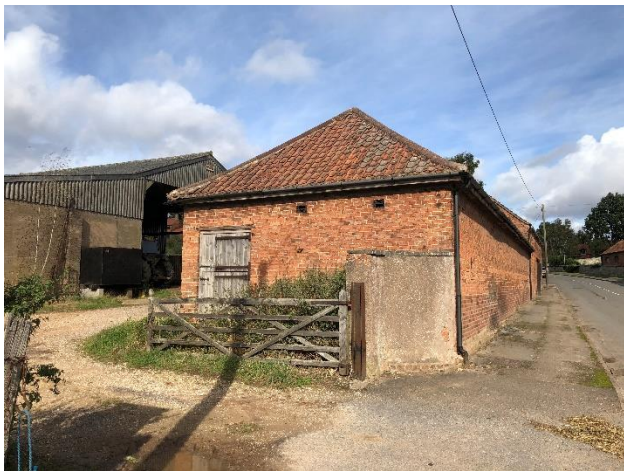
Fig.18 Modern agricultural buildings can be seen, typically located behind the traditional buildings

behind the traditional farm buildings. However, some have been constructed to create covered areas between the traditional buildings and are therefore very intrusive within the farmyard.

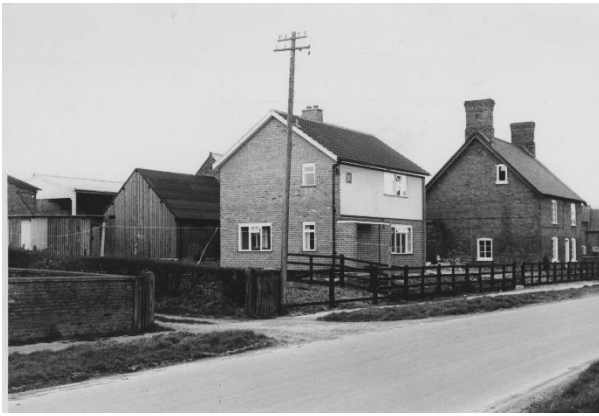
Fig.19 *New Smithy and Old Smithy Farmhouse adjacent to each other prior to the demolition of old Smithy*

During the 1960s redevelopment some historic buildings, including Smithy Farm were demolished. The modern farmhouse, Bar Farm was built with the intention to demolish Old Bar Farm. However, due to bad weather, this didn't happen and since then, the building has been listed. This has resulted in the historic farmhouse being detached from its agricultural buildings, therefore losing its agricultural context.

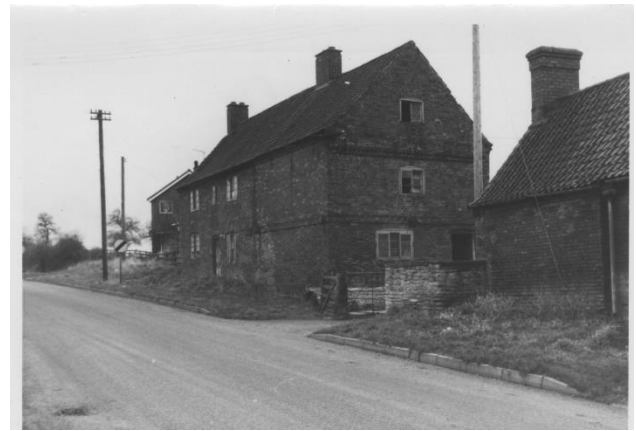
Fig.20 *Although a modern replacement was built to replace Old Bar Farm, the building was saved from demolition due to the weather*

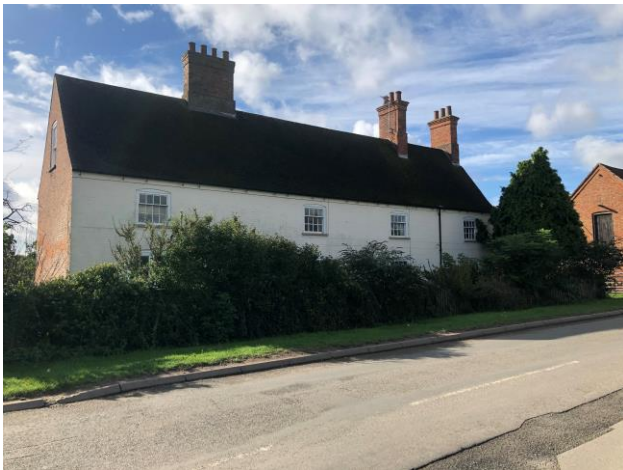
Fig.21 Some of the traditional buildings are limewashed/painted

The overriding character of the village is the vernacular qualities of the buildings influenced by the availability of local materials. Local red brick was widely available during the 18th century redevelopment of the village, resulting in the widespread use of the material. The local material is a reddish orange, which is reflective of the local geology. Some traditional buildings are lime washed/painted.

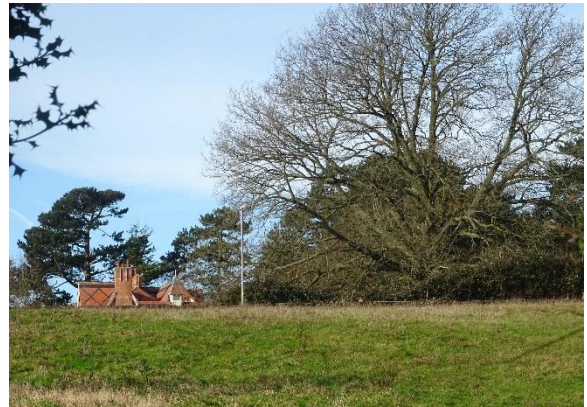
Fig.22 View of the Vicarage's Roof Over the Paddocks from Main Street

as the Vicarage have a plain clay tile (albeit coursed decoratively).

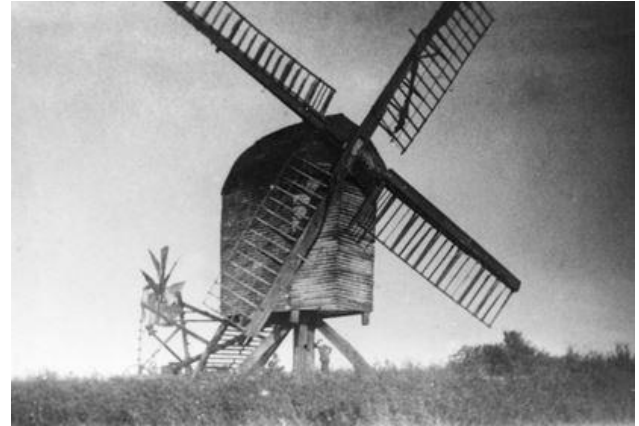
Historic map regression shows us that there were also examples of other types of industrial buildings, including a smithy located within the village and a windmill located on Mill Field.

Fig.25 A Photo of the Mill that was located in Mill Field

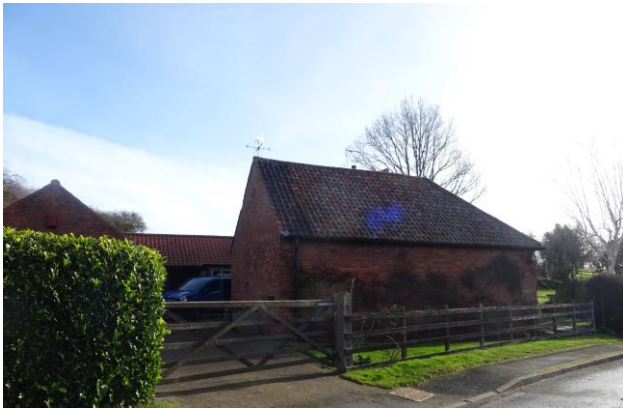
Fig.26 Hollybush one of few barn conversions in Laxton

Few of the traditional agricultural buildings have been converted into residential use. There is only one converted barns complexes (at Hollybush), but as this takes the form of an ancillary range to the main dwelling, it has not resulted in subdivision of the site.

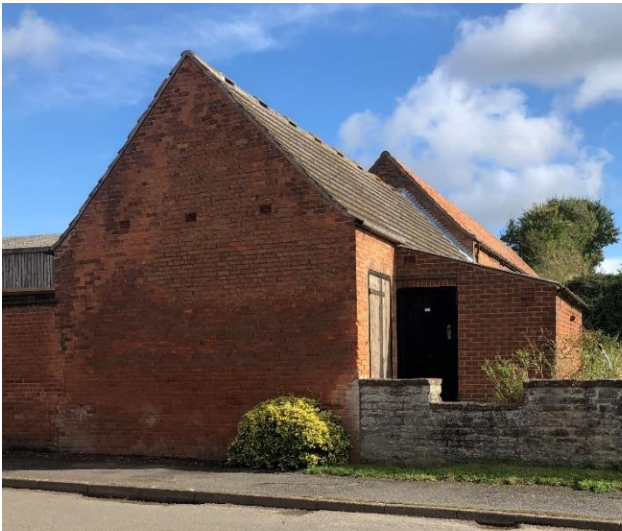
Fig.28 Some boundary walls have lower sections to pass over the milk churns

Hard boundaries are largely red brick. Some brick boundaries have been rebuilt at a taller height. Some of these still retain a lower section, this lower section is a traditional feature to pass over the milk churns. There are also some stone brick walls, most notably to the Church of St Michael.

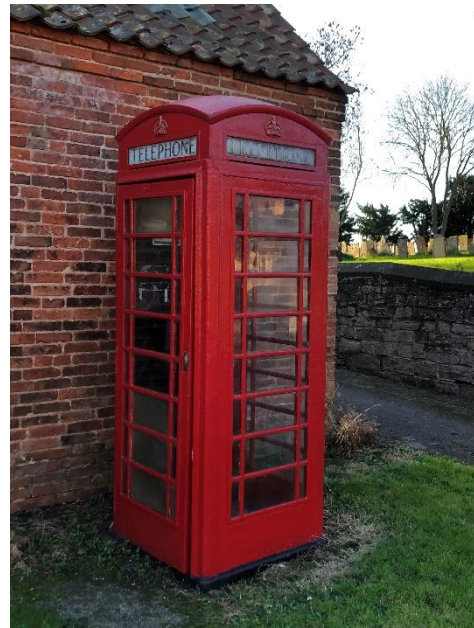
Fig.29 Grade II listed K6 telephone kiosk located along the High Street

A grade II listed K6 telephone kiosk is located on the High Street. The K6 telephone kiosk was introduced in 1935 by the eminent architect Gilbert Scott to celebrate the jubilee of King George V. They are the most common on telephone box to survive.
